# Modern Solutions for Rehabilitation of Old Reinforced Concrete Structures

The paper deals with the results and design recommendations obtained from an experimental programme and its application on a structural rehabilitation.

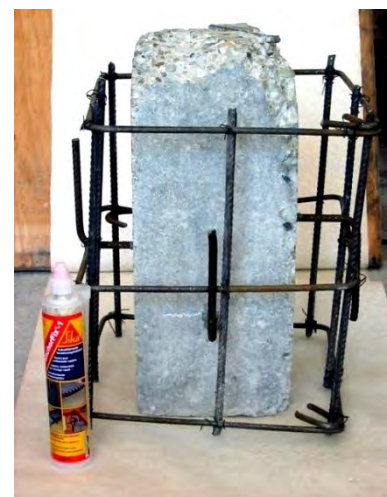
The connection between the substrate (RC prism) and the added concrete (RC jacketing) were: concrete-to-concrete bond; bonding agent as epoxy resin; chemically (Fig. 1) or mechanically anchored steel connectors.

*Fig. 1: RC columns strengthened by RC jacketing*

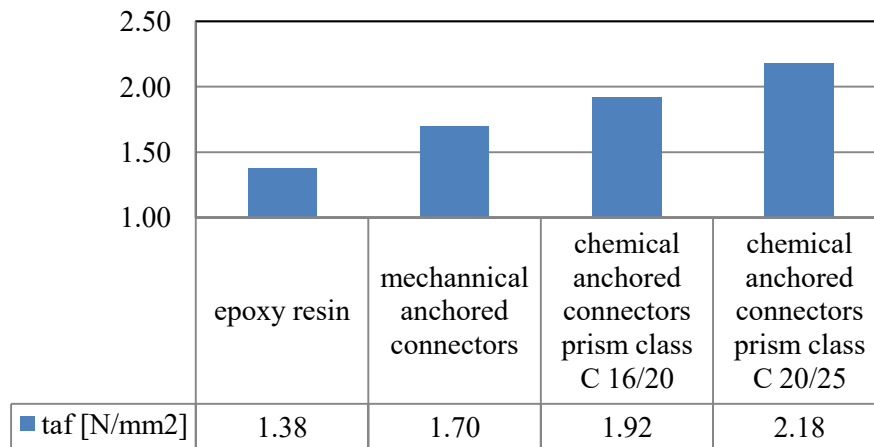
The results of experimental tests are presented in Table 1 and Fig. 2.

Fig. 2: Influence of bonding solution on bond strength

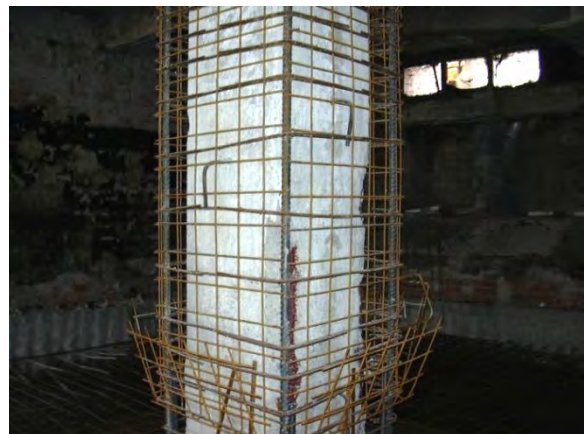
The factory has been assessed and rehabilitated. The main problems comprised local damage of some structural elements and weakness of reinforcement of columns and beams at present-day magnitude of seismic action. Local damages were observed and assessed at slabs, main girders, secondary beams and columns. The damage consisted of: concrete cover dislocated over a large surface; corrosion of many stirrups; deep corrosion of main reinforcement.

Weakness of reinforcement was deduced from the structural analysis. The initial analysis, done in 1940, was performed according to Romanian norms, under which aseismic design was inadequate, owing to weakness in the structural system. On the other hand, weakness of shear reinforcement was deduced; inclined cracks were noticed at some main girders.

Fig. 3: RC strengthening of columns

The rehabilitation of the RC structure, performed in 2008, was adopted for both types of damages. The strengthening consisted in jacketing with reinforced concrete of columns and foundations. For columns the previous experimental studied solution was adopted by using chemical anchored connectors (Fig. 3). The strengthening solution adopted for beams and slabs was based on carbon fibre polymer composites (CFRP): longitudinal CFRP lamellas and transversal CFRP wrap for beams; CFRP wrap for slabs.
