Rehabilitation of a Viaduct Subjected to a Landslide Thrust

Luis B. FARGIER G.

Rosendo CAMARGO M.

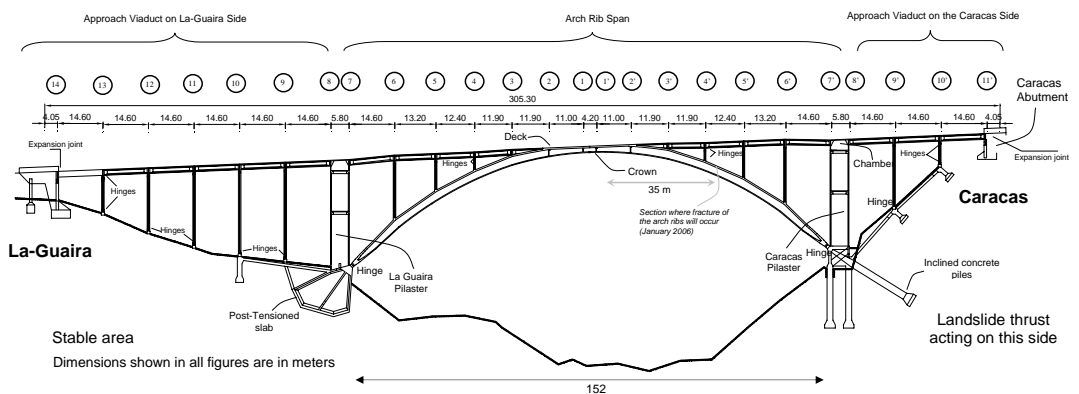
Fig. 1: The Viaduct Subjected to the Thrust

The viaduct No.1 is shown in Figure 1. It consisted of three parallel concrete ribs, hinged at their bases, built without longitudinal reinforcement, and two approach viaducts located at both sides of the arch span. The structure was located on the Caracas-La Guaira highway, approximately 4 kilometers away from the city of Caracas, capital of Venezuela.

Cracking of the grade beams first observed in 1987 led to an extensive geotechnical investigation. Results from these investigations indicated the existence of an ancient landslide affecting the Caracas side of the viaduct. Surface monitoring showed that the landslide displacement vector intersects the viaduct at a 45 degree angle, thus inducing transverse and longitudinal displacements

on the portion of the structure sitting on the Caracas side (Figure 2). A site inspection conducted in 1987 indicated that the expansion joints located at the abutments were closed. Because the arch ribs and the deck become a solid member at the crown, as shown in Figure 1, the arch ribs are restrained to advance longitudinally if the expansion joints between the deck and the abutments are closed. Thus, the first rehabilitation measure conducted on the viaduct (December of 1987) consisted of a concrete demolition of the deck to create a gap at the joints. It is worth mentioning that the expansion joints continuously closed, as a consequence of the landslide thrust and needed to be reopened in several opportunities, as it was done in December of 1987.

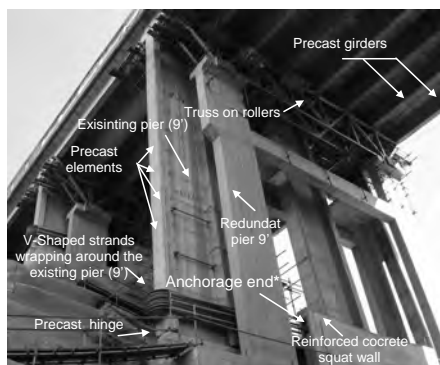
Fig. 3: Lateral and Gravity Load Redundant Systems at Pier 9'

* This end provided anchorage for V-shaped strands that wrapped the column pier located further to the right in the picture.

In 1993 a redundant gravity load resisting system was built on the access viaduct located on the Caracas side, as shown in Figure 3. It consisted of a redundant steel truss at the Caracas abutment, a set of paired steel trusses supported on a redundant concrete piers located at either side of piers 9' (Figure 3) and 10', and a group of steel struts that supported the precast girders inside the chamber located on top of the Caracas pilaster. The entire redundant system was supported on rollers placed in the transverse direction of the Viaduct.

A redundant lateral load resisting system was built at the base of piers 9' and 10', as shown in Figure 3. Heavily reinforced concrete (RC) squat walls were built at both sides and parallel to each of the piers. The squat walls provided anchorage ends for a pair of prestressing strands each of which wrapped the existing piers in the transverse direction in a V-shape. Additionally, the ribs were post-tensioned (Figure 4) and a plastic hinge was designed at their crown. The idea was to convert a statically indeterminate arch rib, with two hinges, into a statically determinate one, with three hinges: two real hinges and one plastic hinge (PH) at the crown, and thus practically immune to the longitudinal thrust. Reinforcing details for the PH are shown in Figure 5. The statically determinate arch ribs made it possible for the viaduct to accommodate net deformations up to 190 cm.
