## Replacing damaged PSC Suspended span of Varsova Bridge across Vasai Creek on NH-8, Mumbai, India.

The existing Varsova Bridge across Vasai Creek, called as Bassein Creek Bridge when constructed, was opened to traffic in 1968. It is in Mumbai Ahmedabad section of NH-48, about 35 Km from Mumbai. Major cracks were noticed in the West side girder of the penultimate span from Mumbai end on 12<sup>th</sup> December 2013. The site was inspected for assessment of the damage. It was decided to replace the said span with composite steel girder. The real task was to dismantle the existing PSC span without any debris falling in the creek while working in a very restricted work area as well as within a very short period. This paper discusses the replacement done, deliberating about the constraints imposed from the design, construction and situation; formulating replacement scheme; design of new structure; dismantling the damaged PSC span and its replacement with composite deck i.e. steel girders and concrete deck slab.

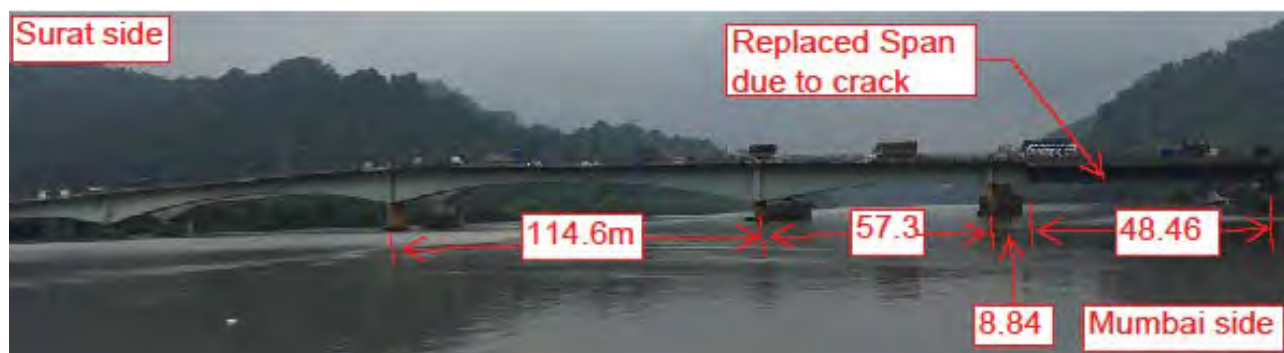
Figure 1: Elevation of bridge showing replaced span.

The Bridge is 555.32m long with 8 spans. The span arrangement is 48.46 + 2 x 57.3 + 2 x 114.6 + 2 x 57.3 + 48.46 m. Main spans from central three piers were built with balanced cantilever
