STOVNER TOWER: ACCESSIBLE PEDESTRIAN WALKWAY TO THE FIORD VIEWPOINT.

Authors: Birger OPGÅRD¹, Gaute MO¹, Fernando Ibáñez² and Altea CÁMARA²

Affiliation: ¹ Degree of Freedom AS, Brenneriveien 5, 0182 Oslo, Norway

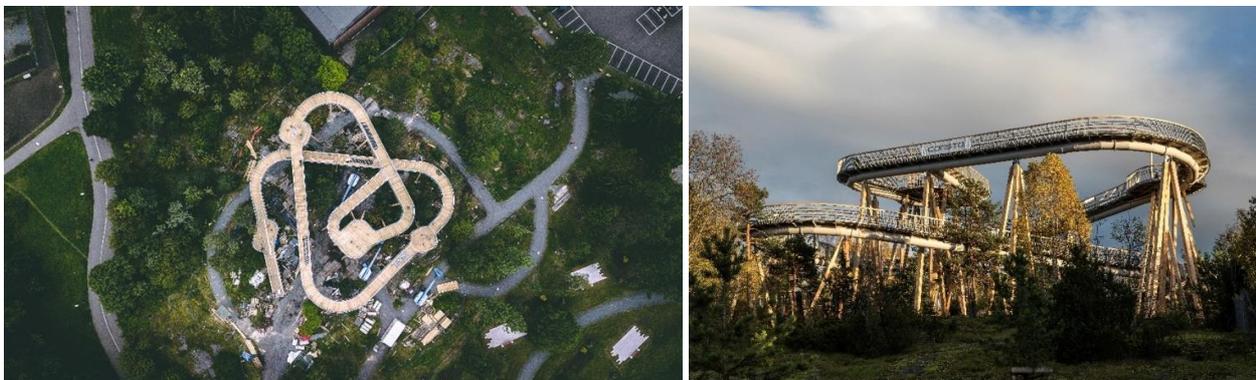
Fig. 1. Left: Aerial photograph of the structure during construction. Photo: Monir Jonas Kadah. Right: Stovner tower structure. Photo: Jiri Havran.

The structure is slim and light and the materials and colors are natural in order to integrate in the park with the minimum visual impact. The principal deck structure is steel, formed from a central tube with a diameter of 762mm. The tube is made up of a series of 2m long straight segments which form the walkway change of direction. Steel cantilever ribs are located at 1.5m centres to support the solid timber decking and the guardrail. The central steel tube is supported at multiple locations by tripod columns formed from three glulam timber sections of variable size depending on their height.

The timber columns are anchored to the bedrock located close to the surface in this area. Steel walkway sections were shop welded in transportable lengths with bolted on-site connections. Timber to steel connections were also bolted. Steel is painted for corrosion protection and all timber is treated for external use. A 3D SAP2000 FE model was used for verifications, including a buckling analysis for the slender timber columns, and a modal analysis to check for frequencies that would make the structure susceptible to pedestrian-induced vibrations.
