Widening and Rehabilitation of some bridges in Indiana Toll Road.

This paper shows a new approach to the problem of rehabilitation and widening of bridges. Some unique factors are being employed to improve the Indiana Toll Road. The first requirement for the design was to keep two lanes in each direction during the whole construction process minimizing the traffic impediments so the complete demolition of structures was not an option. Therefore a very important engineering effort has been done. After a careful identification of the pre-existing damages, the right treatment was implemented in each. A special treatment against damages produced by de-icing salts has been designed using cathodic protection to avoid cell effect. Each stage of the construction process for the widening has been analyzed coordinating geometrical and structural conditions with traffic management.

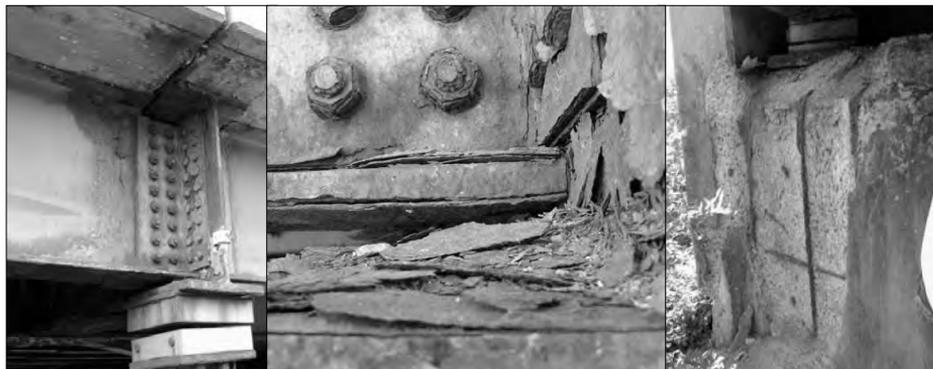
Fig. 1. Left: Steel corrosion below transverse joints. Centre: Delamination and pitting corrosion. Right: Freeze-thaw attack in abutment.

Most of these structures had durability problems due to the effect of massive amounts of de-icing. Structural steel has undergone different levels of degradation.

The most important damages were detected in concrete elements. However, in general the area of re-bars was not decreased.

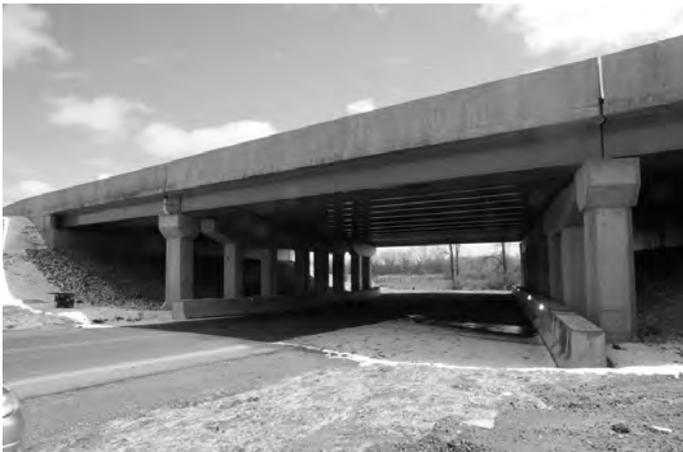
Fig. 3. Hobart Bridge after rehabilitation
