## Lateral-Torsional Instability of Box Girder Bridges at Erection

### Summary

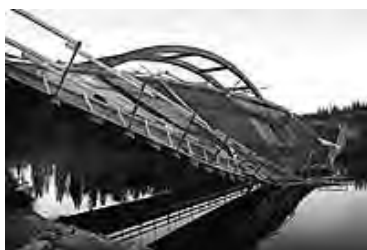
On June the 12<sup>th</sup> in the afternoon, workers started to pour concrete for the deck of the new road bridge Y1504 located 90 km west of town Umea in the northern part of Sweden. The concreting of the deck had deliberately been planned to start in the afternoon in order to avoid strong sunshine which could increase the risk of cracks due to shrinkage. However the sky was overcast most of the day and the sun didn't appear until the evening, when the concreting started. The concreting was planned to be done in two steps, the first one about 66 m<sup>3</sup> covering approximately half of the span symmetrically located around mid span. About 17 m<sup>3</sup> concrete had been poured when the bridge suddenly rotated nearly 90 degrees at mid span and five out of six workers fell into the river. The bridge then took a new state of equilibrium. Fig.1. Fortunately, nobody was severely hurt, and those who fell into the river could reach the riverbank.

*Fig. 1: Lateral-Torsional Instability occurred during casting of the deck slab. The old bridge can also be seen from the photo. (Courtesy of NCC)*

Due to the increasing rotation, the twisting moment caused by external loads will also increase in turn increase the shear flow in the permanent shuttering. This part of the structure is the weakest link with respect to torsional moments. Loss of shear stiffness of this part due to e. g. sheet tearing along seam fasteners or sheet to flange fasteners implies that the box girder acts as an open box girder section characterised by strong warping. It was the capacity of the shuttering to carry the shear flow that was almost entirely decisive for the stability during construction of bridge Y1504.

Outgoing from the collapse during the construction of the Swedish bridge Y1504 a number of aspects concerning the behaviour of open box girders have been addressed. Profiled sheeting used as permanent shuttering is an economically effective solution. This will also improve the torsional rigidity by a factor 10 - 30 provided it is adequately fastened to the top flanges of the box girder. All four sides of the panel should be fastened in order to get a continuous shear flow.

For long single span bridges profiled sheeting of ordinary thicknesses may not give sufficient torsional rigidity. By connecting the top flanges with plan bracing (truss) the torsional stiffness could easily be increased by a factor 100 -1000. With plan bracing present, then the girder will respond as in simple bending with negligible rotation.
